Upgrading/ Improvement of Roadside Slope/
Retaining Walls on Hong Kong Island (2005-
2008 Programme) – Investigation, Design and
Construction

Heritage Impact Assessment Report for Feature No. 11SW-B/R93 (Sub- division 1), Duddell Street

Report Ref: M45/200

Final | June 2013

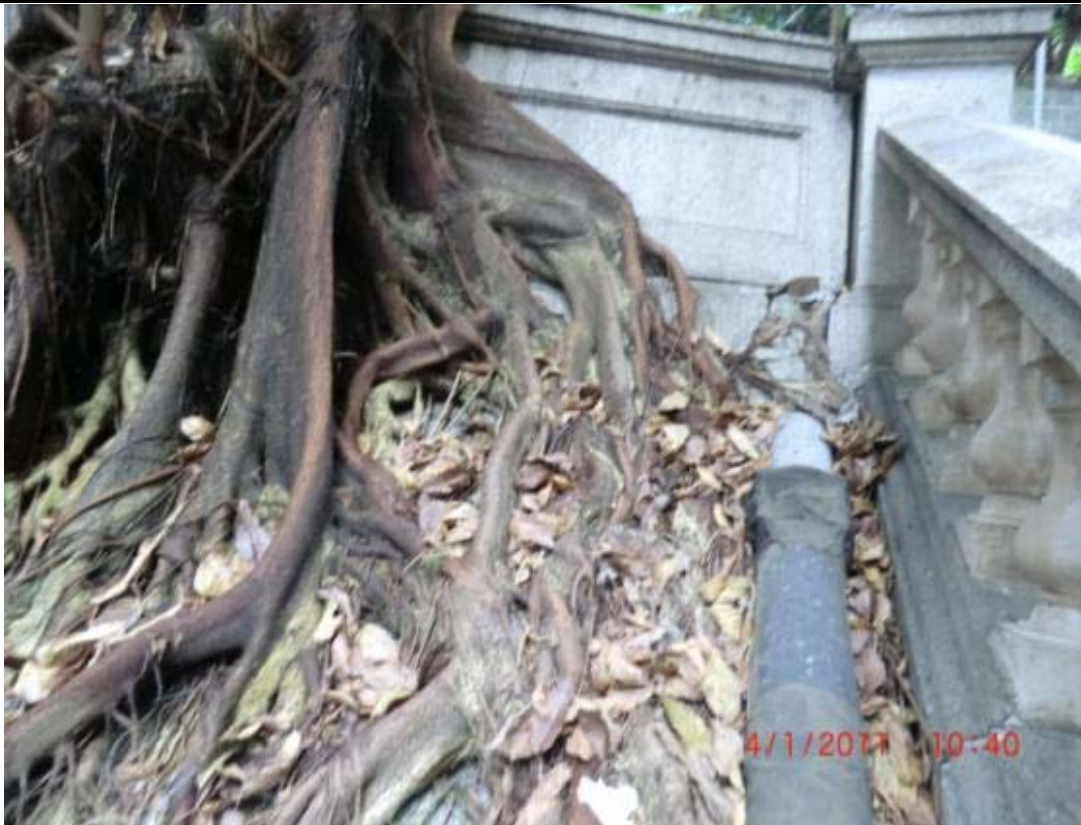
Subject Existing wall trees at the south-western side (Plate 85) **Date photograph taken** 04-Jan-11

Description Numerous of tree roots are observed at the crest of the Feature

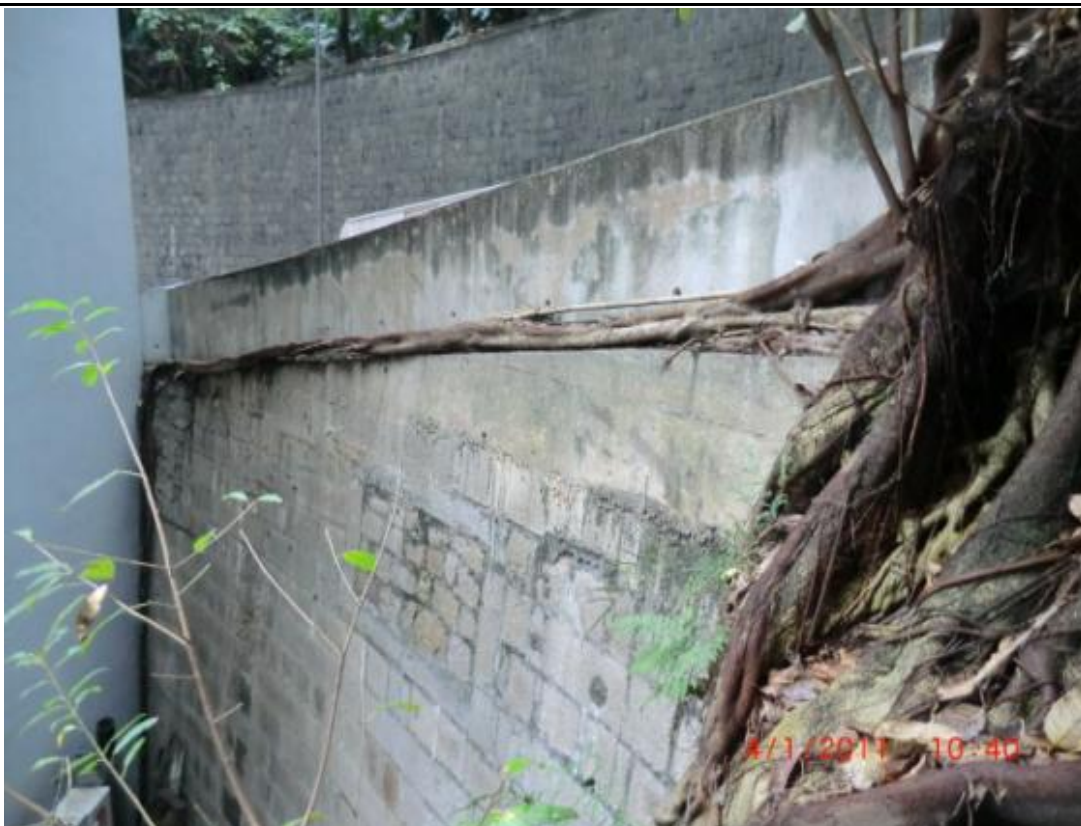
Subject Existing wall trees at the south-western side (Plate 86) **Date photograph taken** 04-Jan-11

Description Tree roots are extended to the Hong Kong Diamond Exchange Building

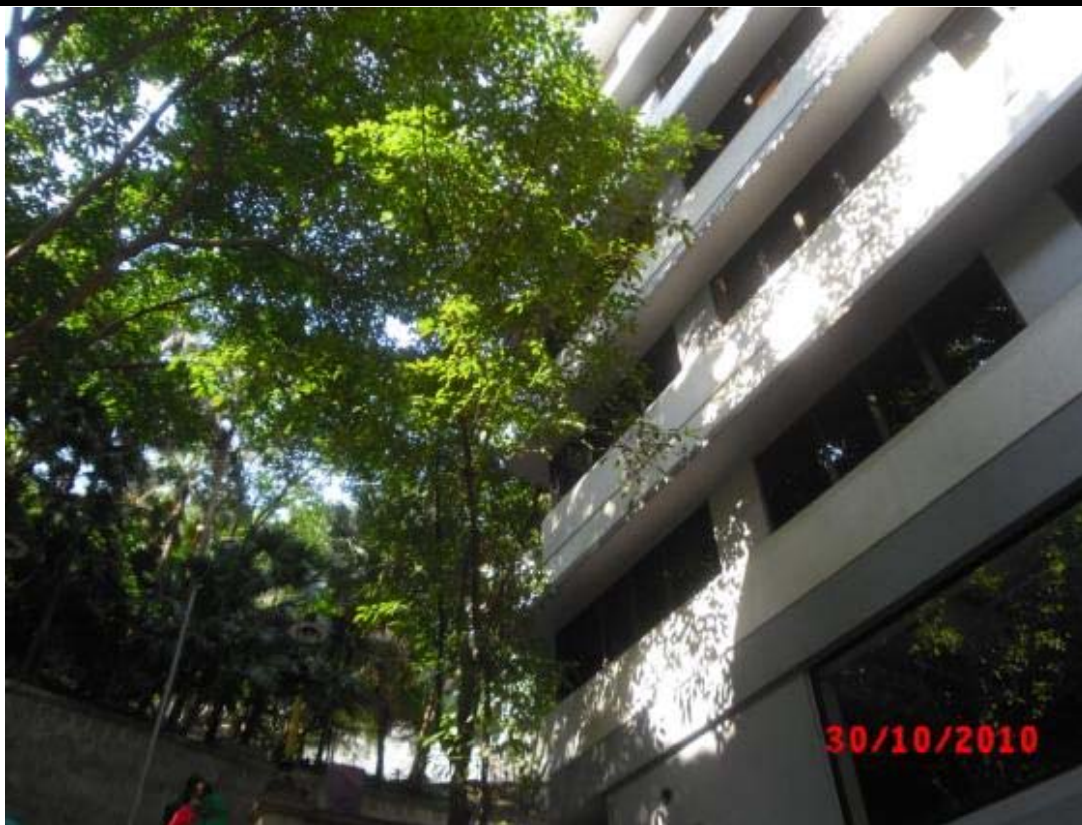
Subject Existing wall trees at the north-western side (Plate 87) **Date photograph taken** 30-Oct-10

Description View showing the existing conditions of wall tree at the north-western side of the Feature

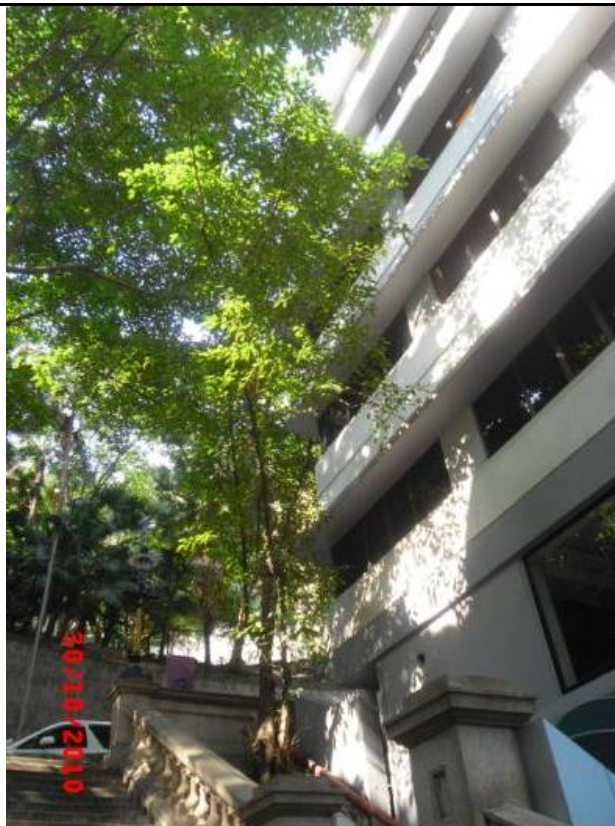
Subject Existing wall trees at the north-western side (Plate 88) **Date photograph taken** 30-Oct-10

Description View showing the existing conditions of wall tree at the north-western side of the Feature

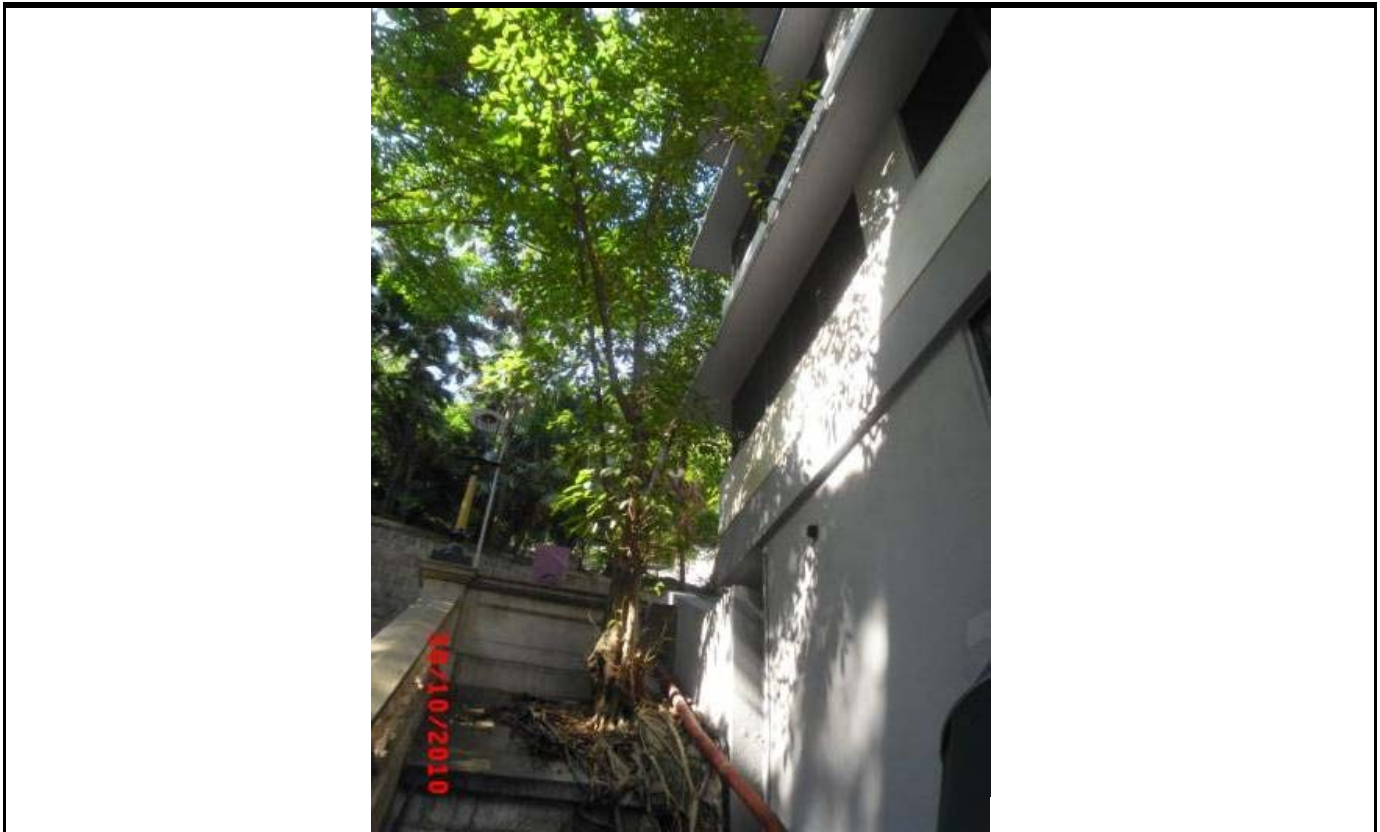
Subject Existing wall trees at the north-western side (Plate 89) **Date photograph taken** 30-Oct-10

Description Numerous of tree roots are observed at the crest of the Feature

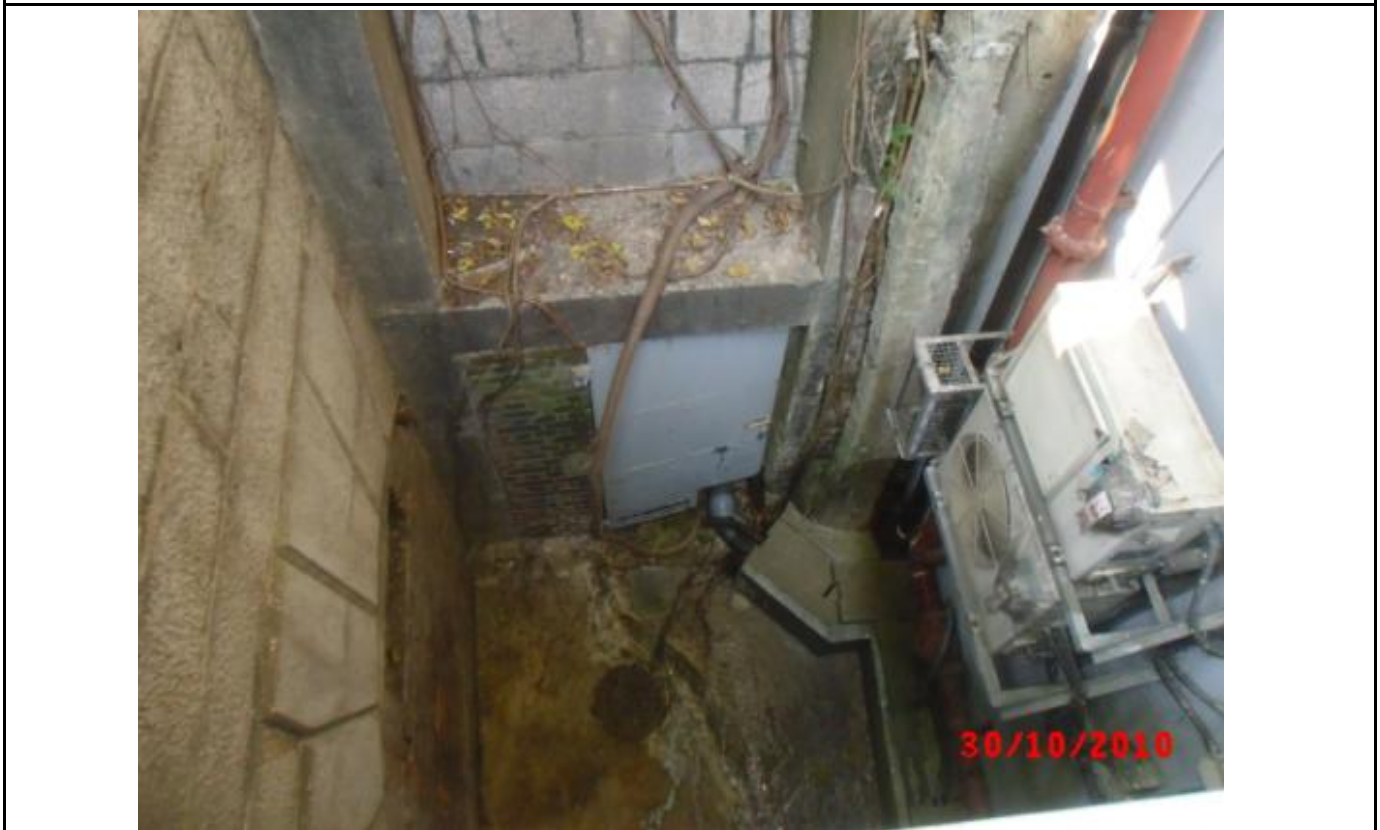
Subject Existing wall trees at the north-western side (Plate 90) **Date photograph taken** 30-Oct-10

Description Tree roots are growing downwards towards the Feature toe

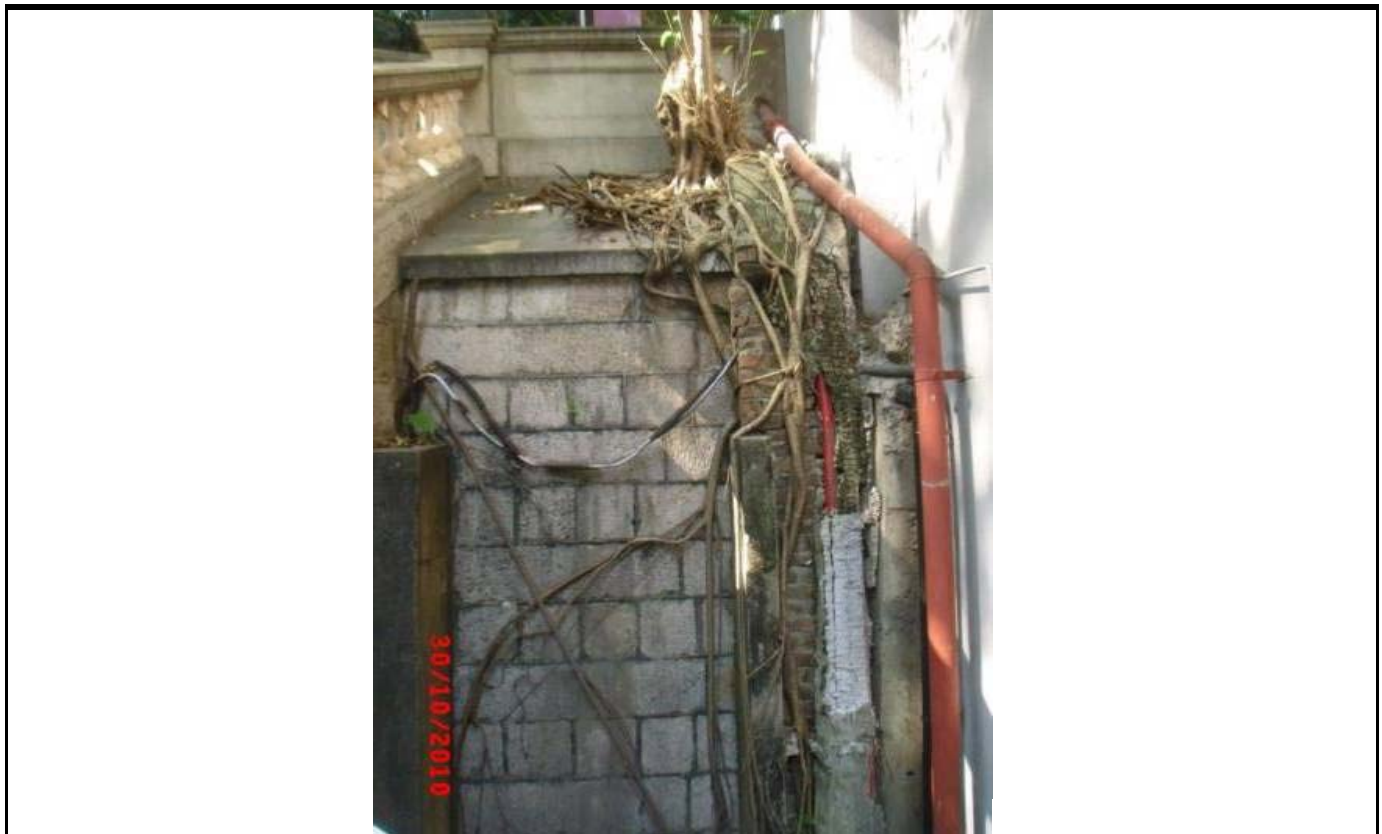
Subject Existing wall trees at the north-western side (Plate 91) **Date photograph taken** 30-Oct-10

Description Some of the utilities are covered by the tree rotts

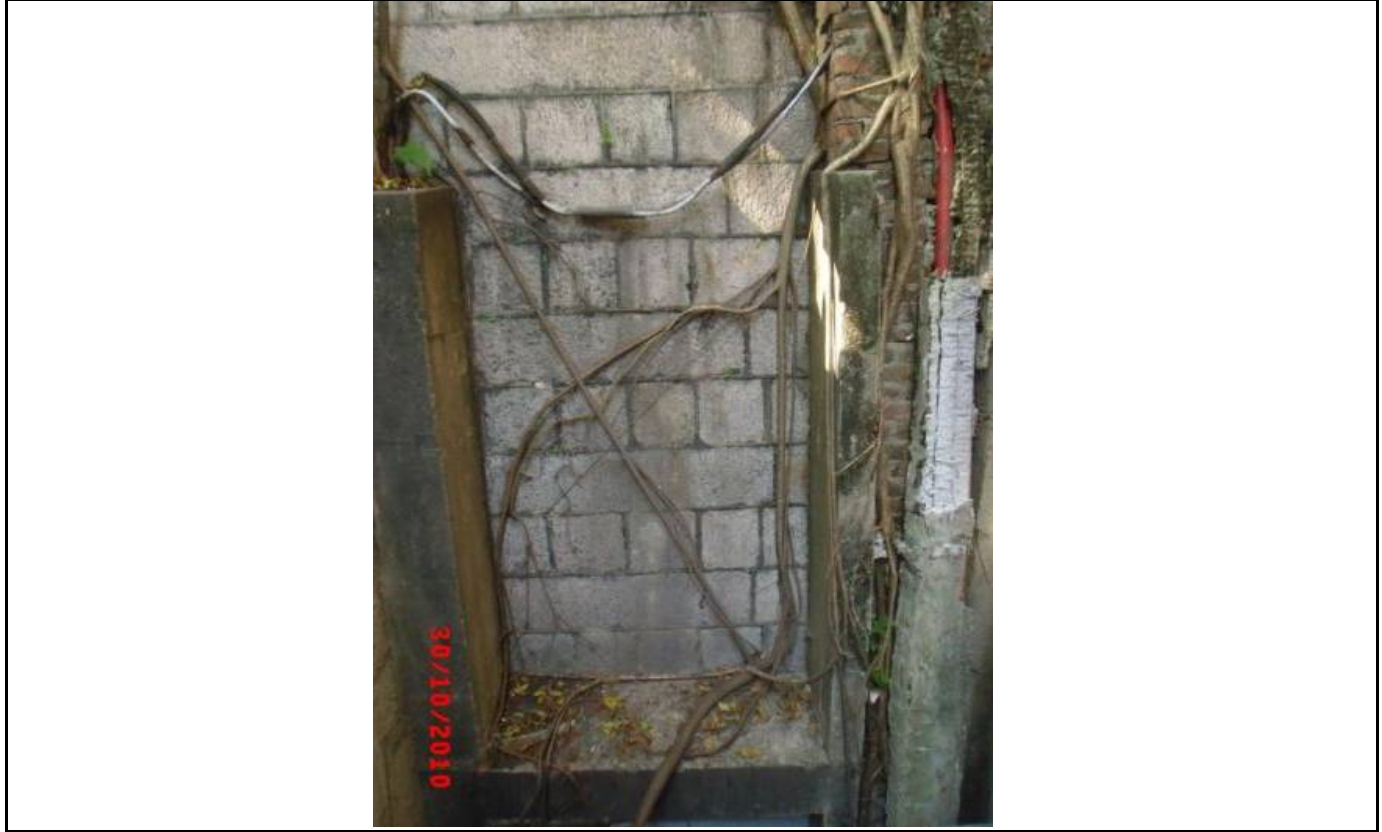
Subject Existing wall trees at the north-western side (Plate 92) **Date photograph taken** 30-Oct-10

Description Tree roots are growing between the counterforts

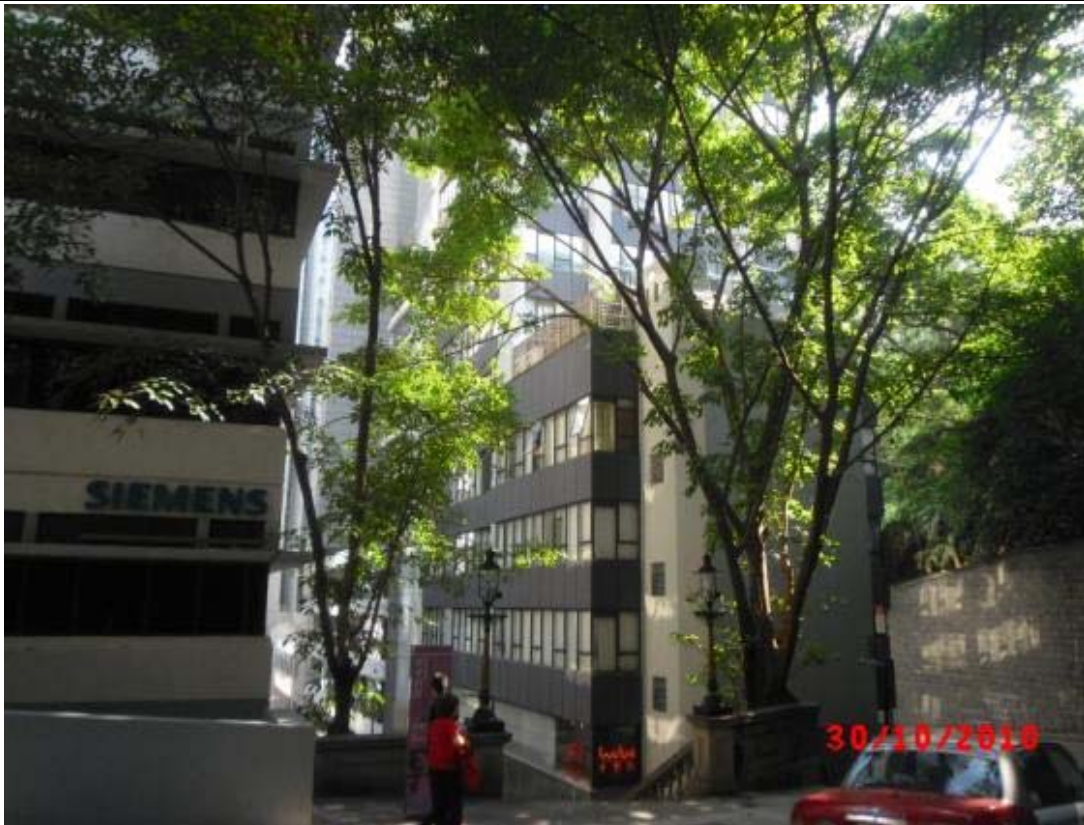
Subject	Existing wall trees (Plate 93)	Date photograph taken	30-Oct-10
----------------	--------------------------------	------------------------------	-----------

Description	View showing the existing wall trees at Ice House Street
--------------------	--
